## Cherry BX-2 Supplement # 6

### Modification of the aileron-controls - drawing D 078

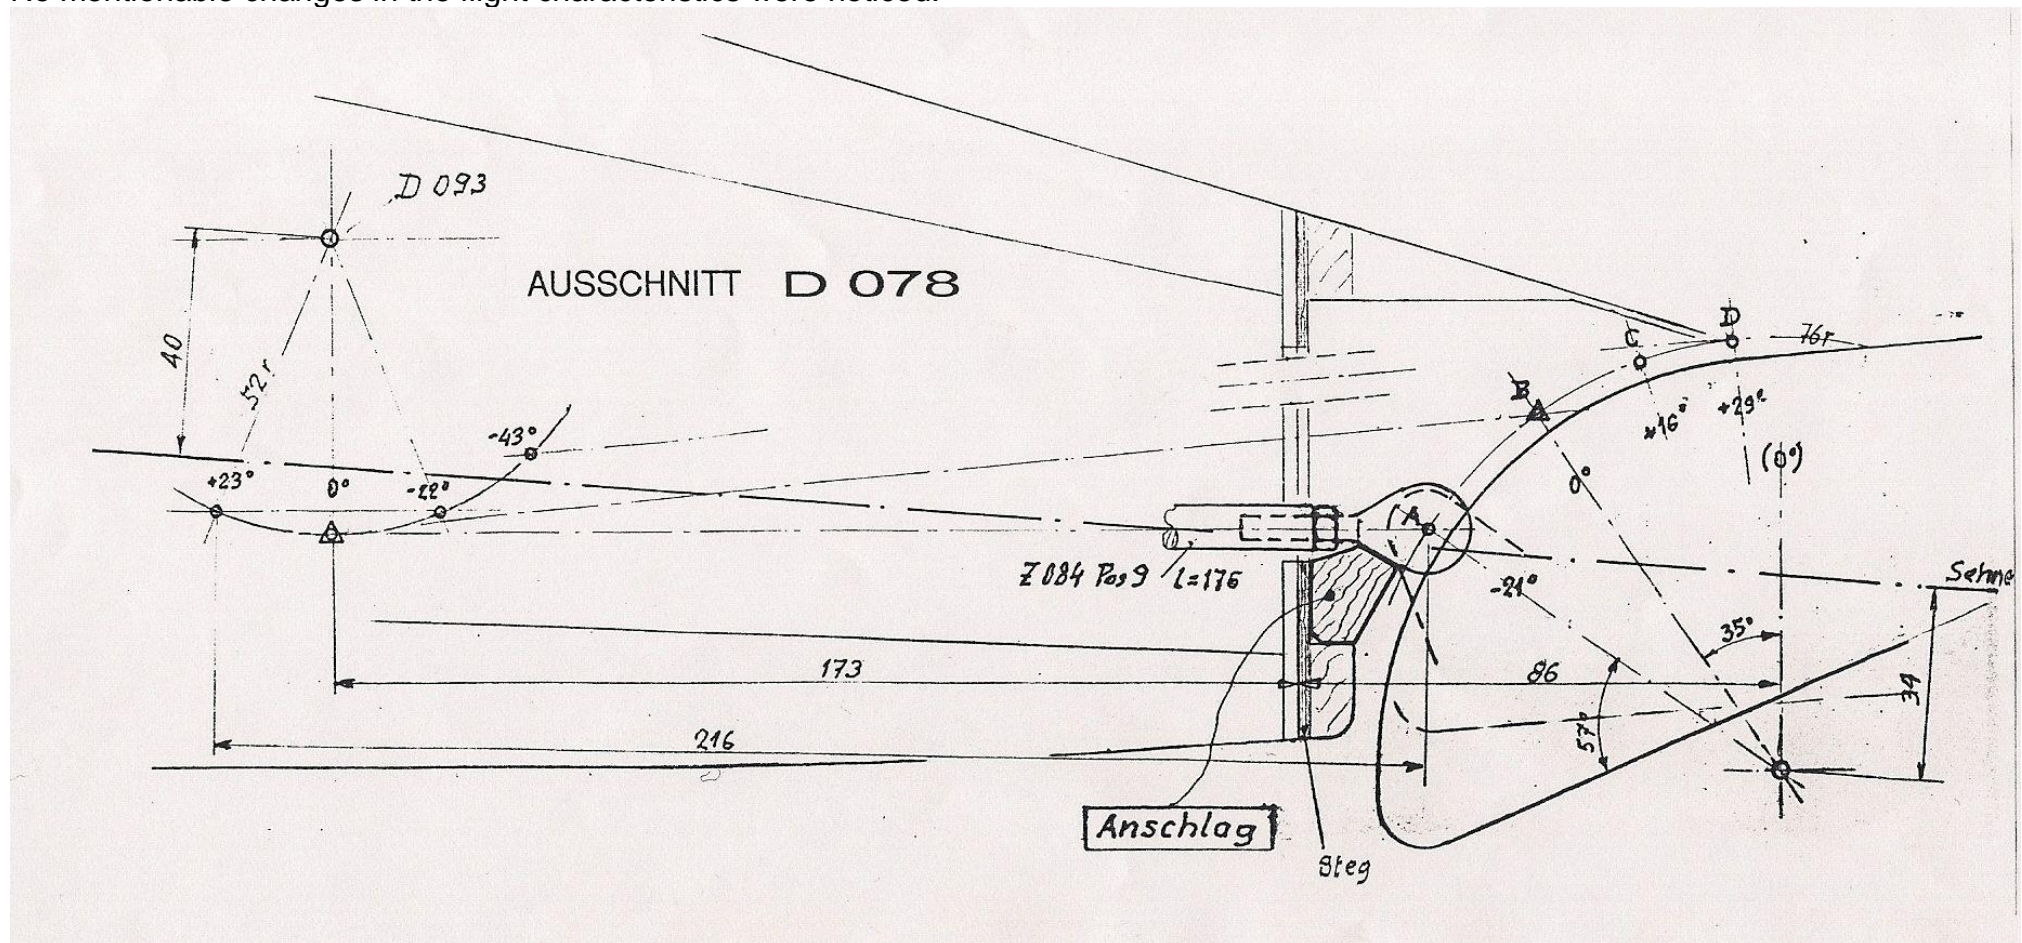
### Modification of the aileron-controls (drawing):

As an additional safety measure, the aileron-stop can be limited at the bearing of the push-rod. The stopper "Anschlag" is build of a shaped hardwood piece with an approximate length of 30 mm which will be glued in place according to the drawing. Doing this the aileron movements will be reduced by 10%. The new ankle-values need to be set with an accuracy of  $\pm 2^\circ$  and entered into the AFM - page 10 (see page 5 - Mai 2004).

Additionally new stoppers underneath the seat are to be fitted for synchronic movement and glued according to Z 075 (Ausschnitt). No mentionable changes in the flight characteristics were noticed.

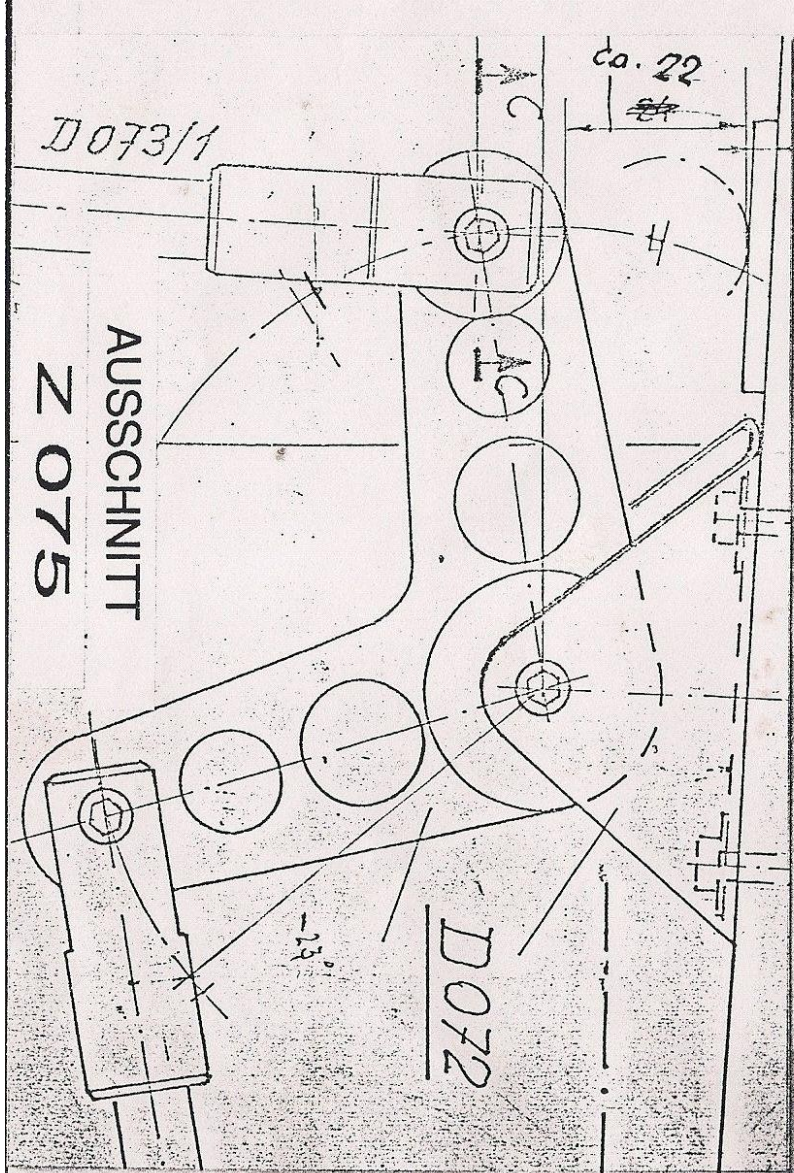
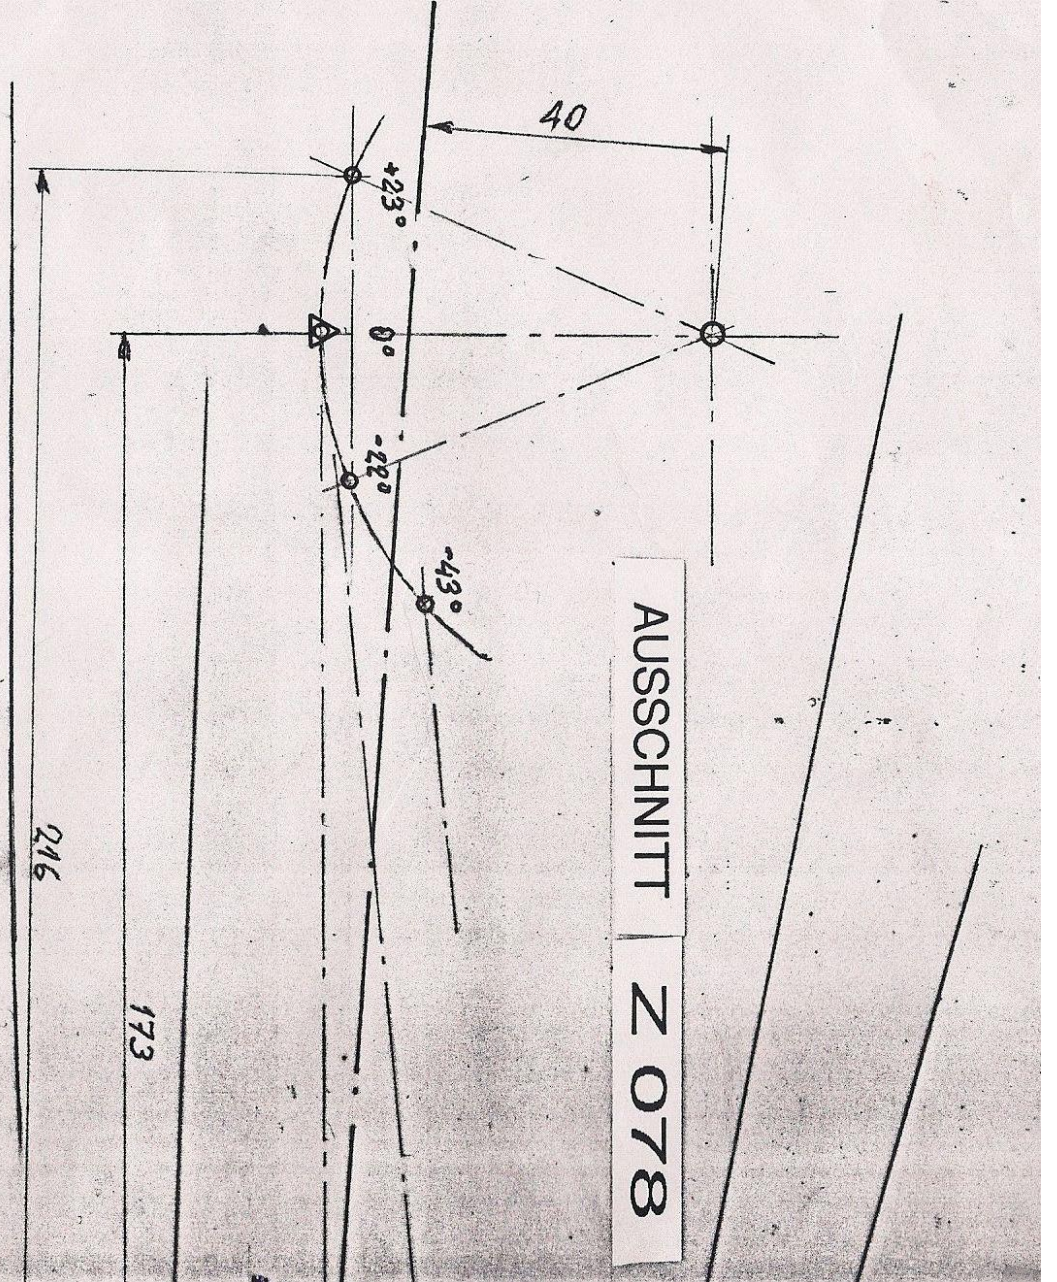
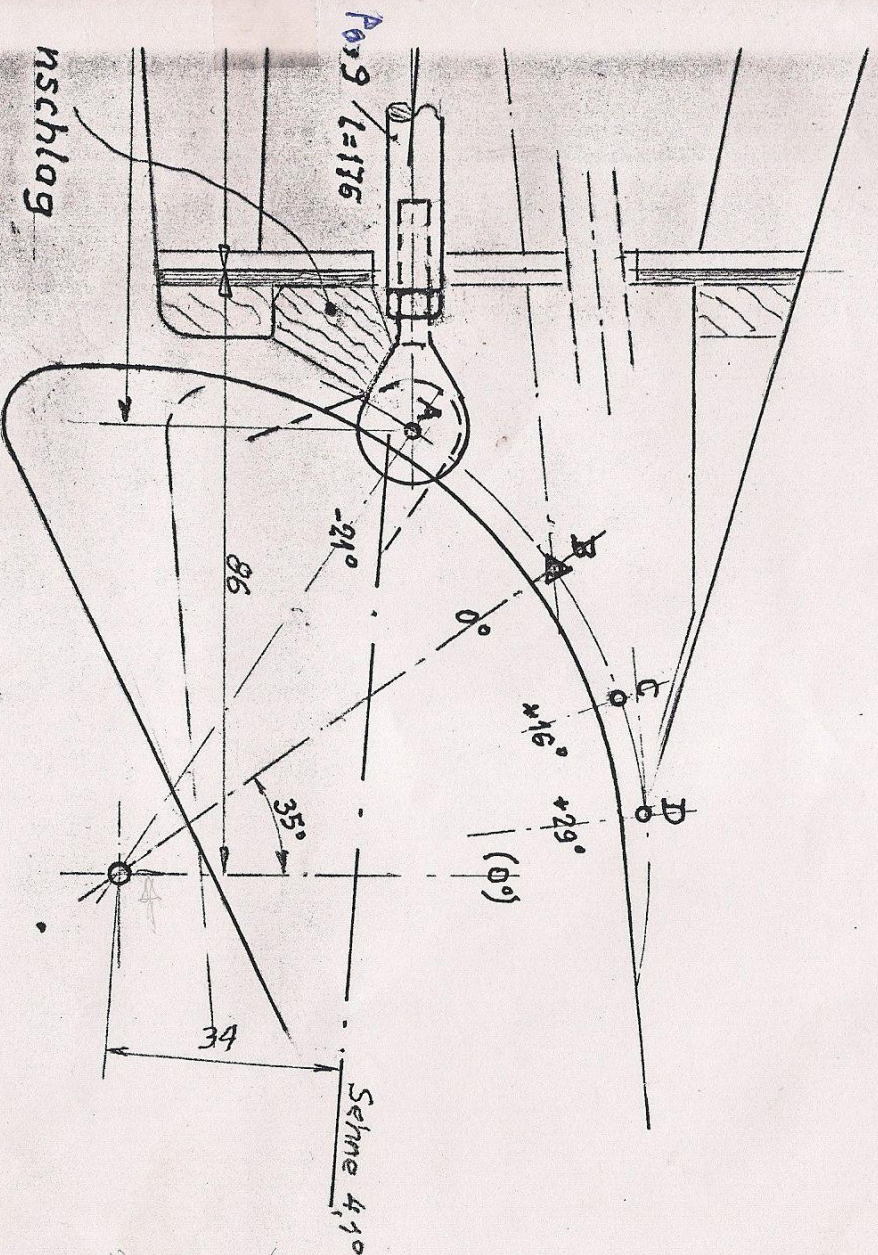
D 078 mod. Querruder - Anschläge

Die Ausschlagwinkel sind leicht reduziert wie folgt:

Pos. A	Flap 0°	QR nach oben	- 21°
Pos. B	Flap 0°	QR neutral	0°
Pos. C	Flap 0°	QR nach unten	+ 16°
Pos. D	Flap 60°	QR nach unten	+ 29°

ZWECK : Begrenzung des Querruder- Ausschlages

A mechanical stop "Anschlag" made of phenol-sheet or hardwood will be fitted and glued on the lower part of the rear wing spar (see attached drawing), limiting the upper Aileron movement to  $21^{\circ}$  (+/-  $2^{\circ}$ ). The stop limits the bearing of the push-rod. Additionally, the stops of the controls underneath the seat get beefed up in order to limit and synchronize both stops on each side (Z 075, "Ausschnitt"). The control mechanism itself will not be changed but the movement (ankle) will be slightly reduced. The new ankle-values for the aileron movement are given in the attached part-drawing D 078 mod. There are no changes to the flight characteristics.

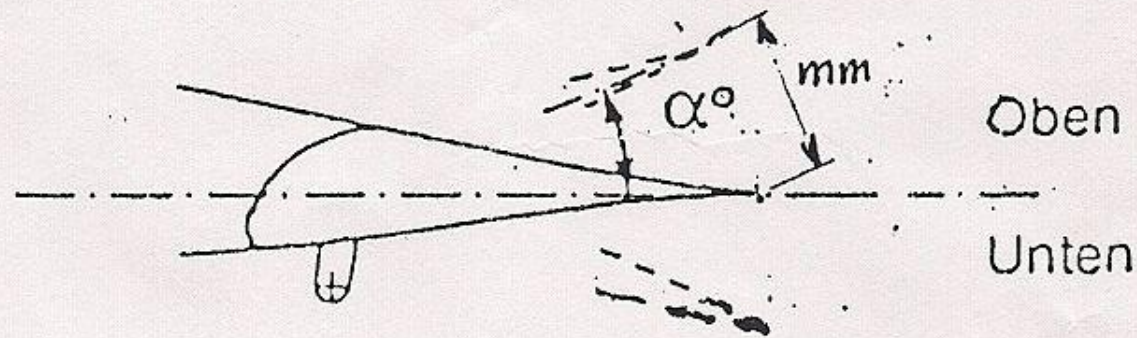
Querruder nach Modifikation D 078 mod. (Mai 2004)  
(bei Antrieb gemessen, Höhenruder neutral)

QR	Flap 0°		20°		40°		60°	
	α°	mm	α°	mm	α°	mm	α°	mm
noch oben	- 21	80			- 8	30	-3	12
nach unten	+ 16	60			+ 24	125	+29	142

The new aileron movement-values are to be entered into the AFM!
